KICKAPOO RIVER MAIN STEM

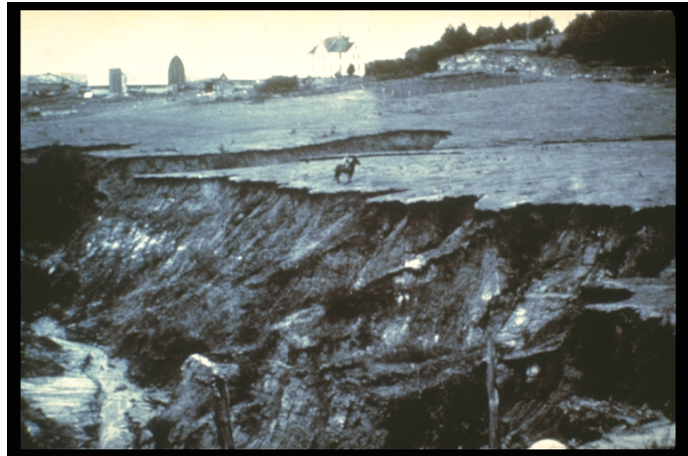
Figure 2. Typical streambank erosion in the Driftless Area circa 1920.

Streambank erosion is a common sight throughout the Kickapoo River. Much of this erosion is not from current land management practices, but rather from severe sedimentation of the valley floor from poor land use management over much of the last century. This additional sediment on the valley floor resulted in the river cutting down through it to re-establish itself. Consequently many areas of the Kickapoo River contain vertical or nearly vertical banks of ten feet or more, limiting access by boats to those areas with more gentle banks.

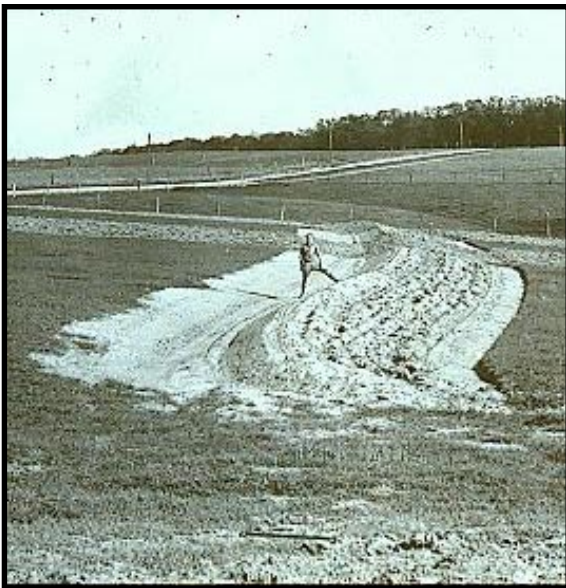
Figure 3. Installation of a field terrace on a Driftless Area farm circa 1934.

Civilian Conservation Corp (C.C.C.) to enter their land and plant trees, fence livestock out of steep slopes, reconfigure fields to follow the hills' contours, plant grassed waterways, and stabilize gullies. Efforts to restore streams were also attempted by the addition of brushmats to eroding banks, wood and rock deflectors to force floodwaters away from streambanks toward the stream's center, and revegetation of raw streambanks. These land management practices were successfully adopted and are still in use today not only by farmers in the Coon Creek watershed, but also farmers in the Kickapoo River Basin as well as the entire Driftless Area, including parts of Minnesota, Iowa, and Illinois.

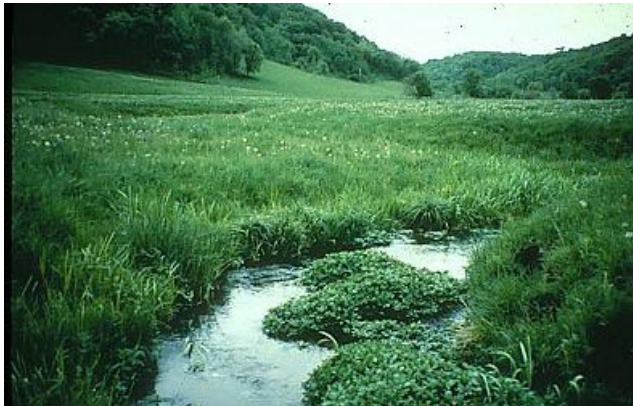
Figure 4. A Driftless Area stream containing watercress in 1997.

Watercress, an aquatic plant indicative of groundwater inflow to a stream, was documented not only at springheads, but also further downstream on many small and medium sized streams.
